Connect Plus Upgrade

September 2011
Version 1.0

1 Introduction

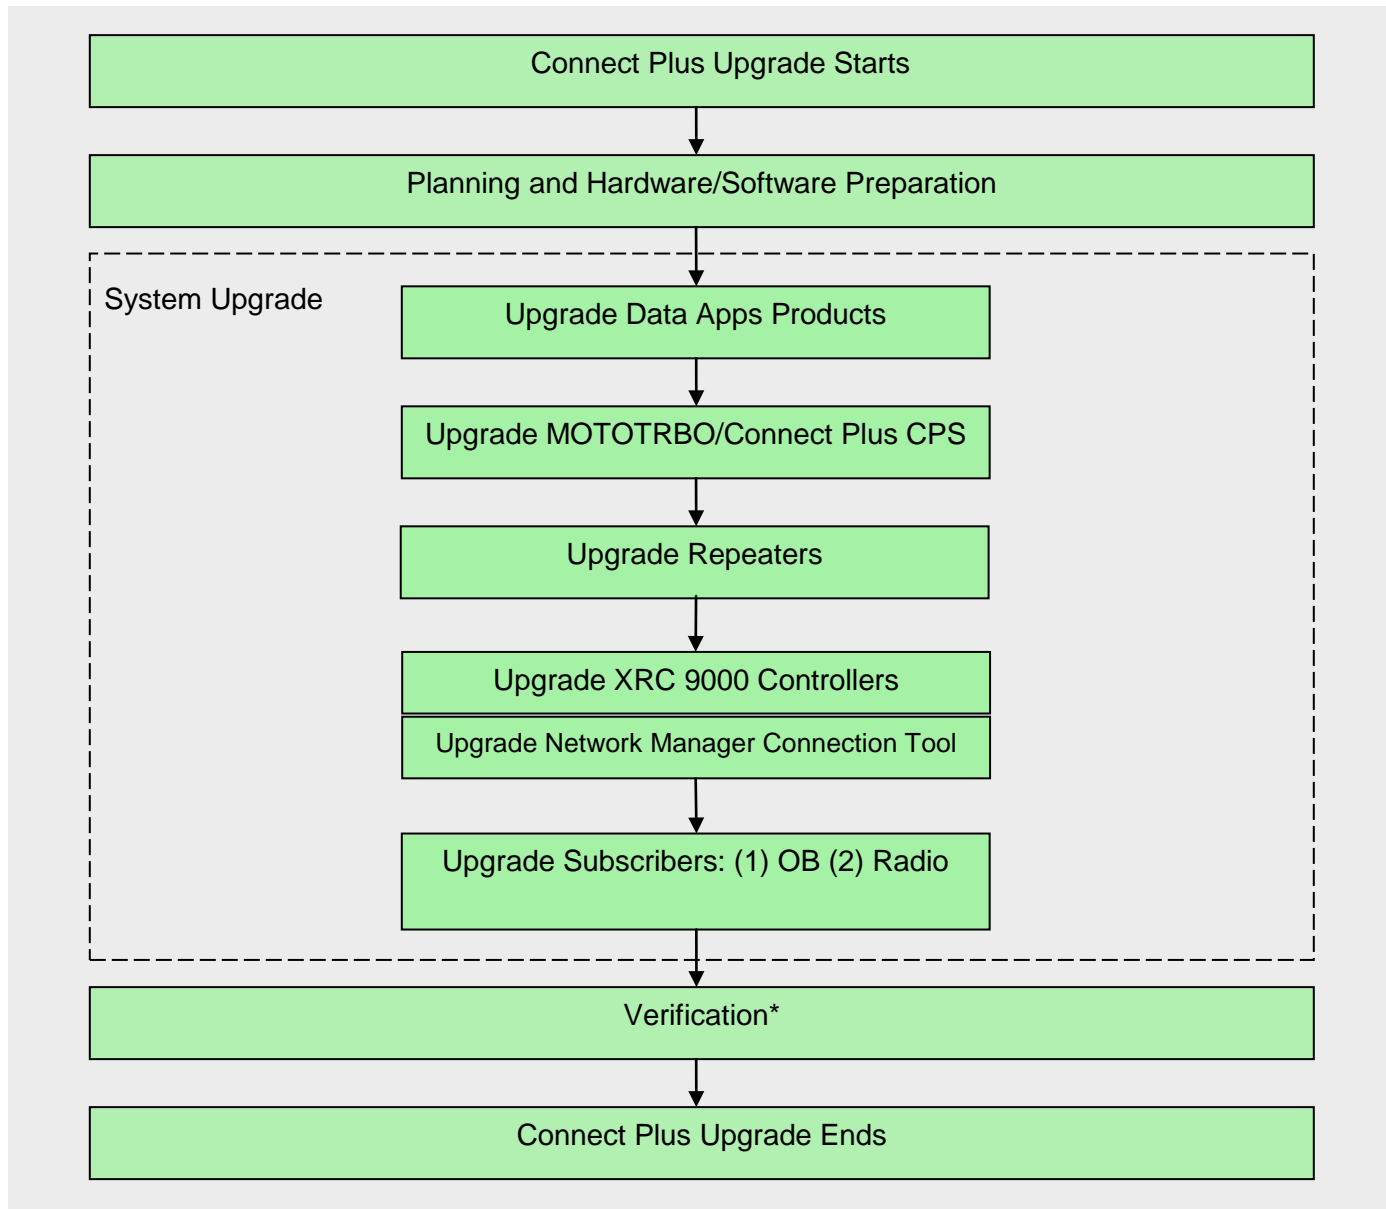
Figure 4-1 Connect Plus General Upgrade Sequence

The Connect Plus system downtime could be minimized if the following recommended upgrade order is followed:

* Verification entails performing basic voice calls and exercising new as well as existing features on the upgraded system. On a multisite installation this process should involve multiple sites.
